DEVELOPMENT OF DESIGN, TEST AND
ACCEPTANCE CRITERIA FOR ARMY HELICOPTER
TRANSPARENT ENCLOSURES

PPG Industries, Incorporated

September 1973

USAAMRDL TECHNICAL REPORT 73-65

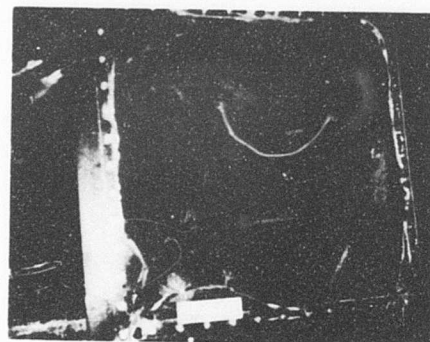
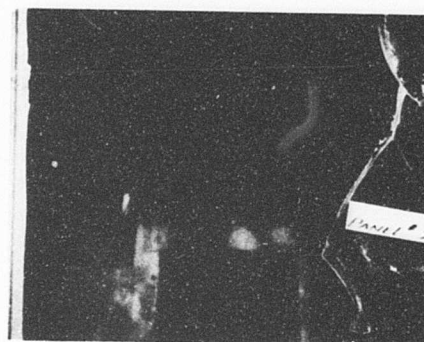
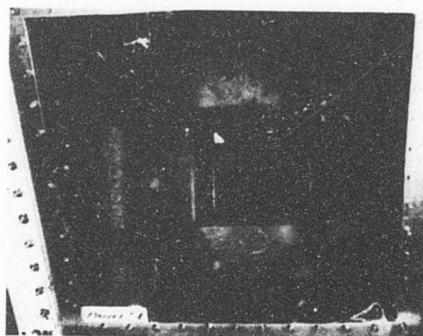
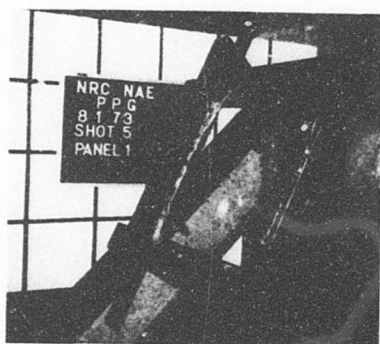
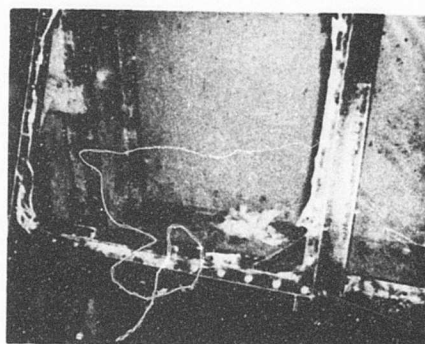
Panel No. 2 at 101 MPH

Panel No. 3 With Rubber Gasket at 100 MPH

Figure 30. Results of 4-Pound Bird Impact Tests of 1/4-In. Stretched Acrylic.

Panel No. 4 With Flexible Aluminum Extension Ring at 100 MPH
Forward

Panel No. 1 At 151 MPH

Figure 30 shows the results of 4-lb bird impacts of 1/4-in. stretched acrylic design as shown by Figure 29 at velocities of 100 and 150 mph. In

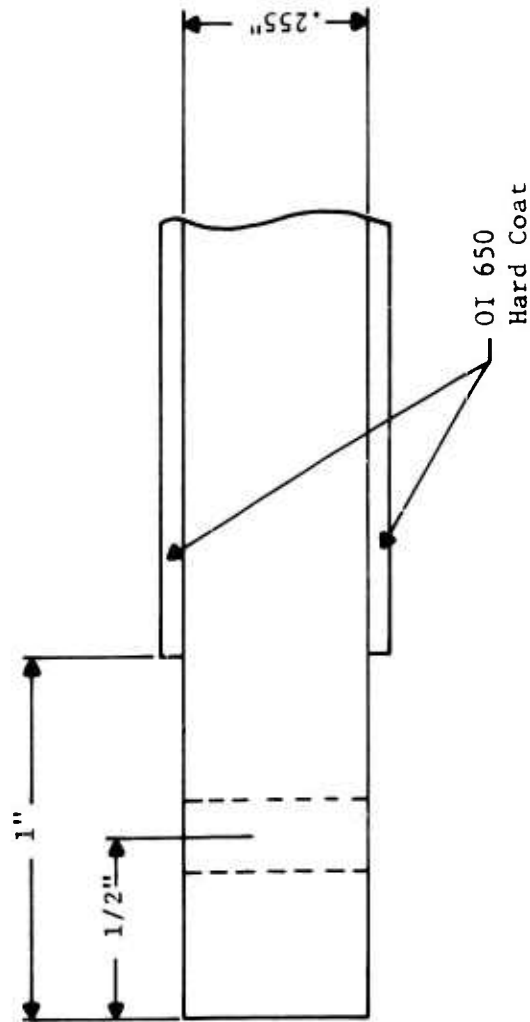
Figure 31. Design II: Monolithic 1/4-In. Polycarbonate with Hard Coat.

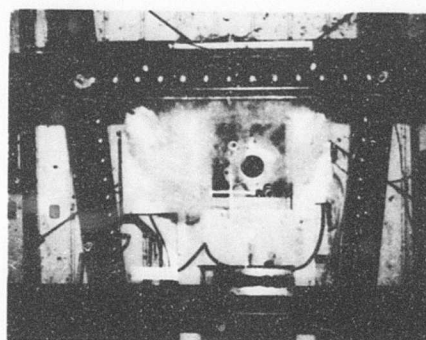
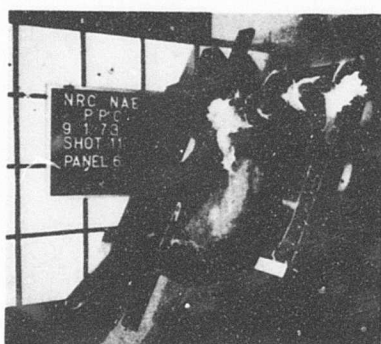
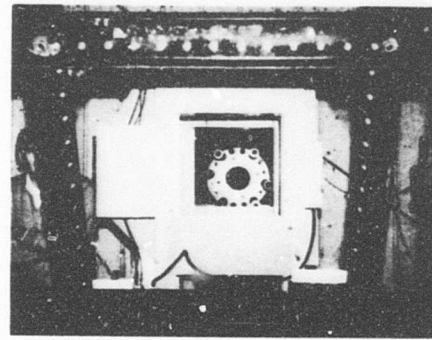
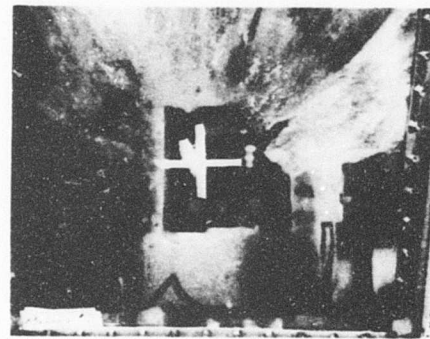
Panel No. 5 at 200 MPH

Panel No. 6 at 250 MPH

Figure 32. Results of 4-Pound Bird Impact Tests of Optically Perfected, Hard Coated 1/4-In. Polycarbonate.

Panel No. 8 at 250 MPH

Panel No. 7 With Flexible Aluminum Extension Ring at 250 MPH

The results per Figure 32 show that 1/4-in. polycarbonate, optically perfected with hard coat, bounced the bird at 200 mph but was penetrated at 250 mph. At 200 mph, a few cracks developed around the bolt holes along the top edge. The major amount of bird remains around the top of the frame for the 250 mph impact of panel No. 6 indicates the panel showed some resistance to penetration. The failure started in the vicinity of the second bolt hole

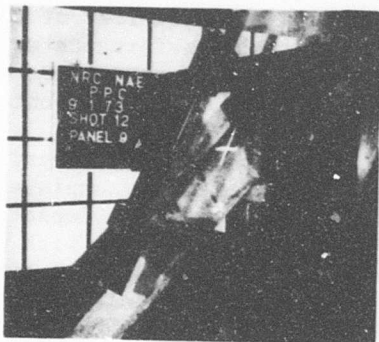
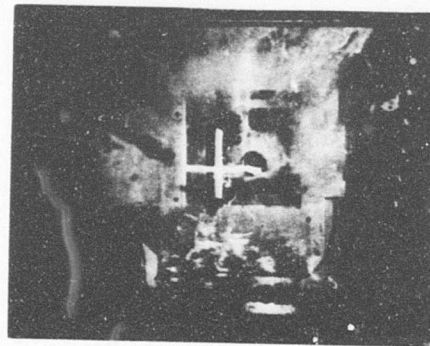
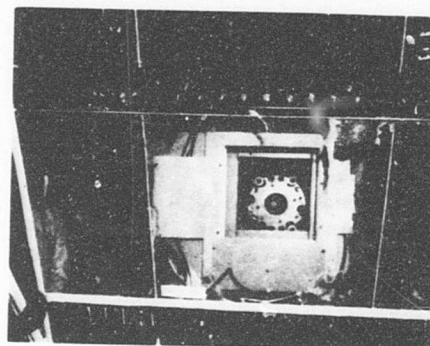
Panel No. 9 at 245 MPH

Panel No. 10 at 277 MPH

Figure 33. Results of 4-Pound Bird Impact Tests of As-Received, Hard Coated 1/4-In. Polycarbonate.

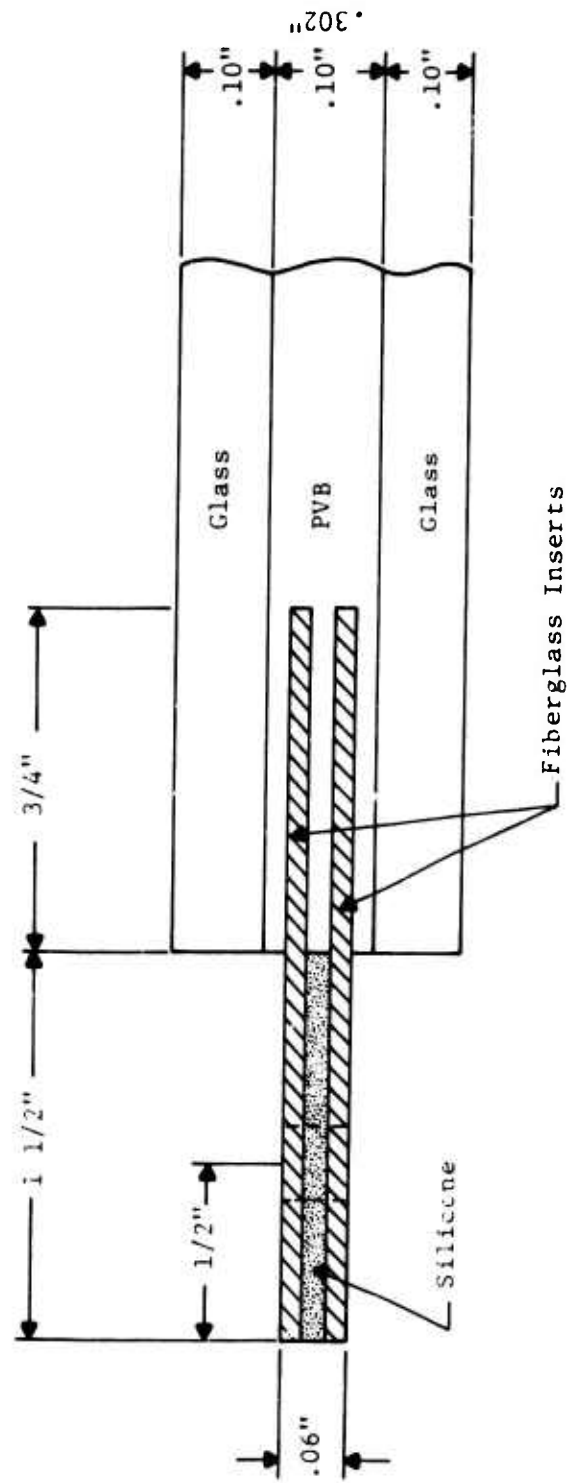
Figure 34. Design III: Two-Ply Glass Laminate
 .10-In. Glass - .10-In. PVB Interlayer -
 .10-In. Glass.

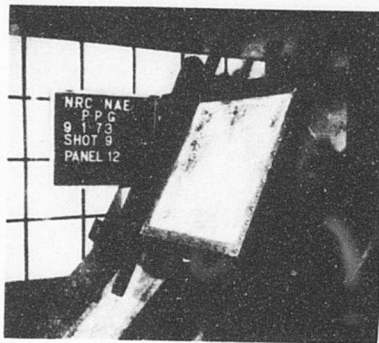
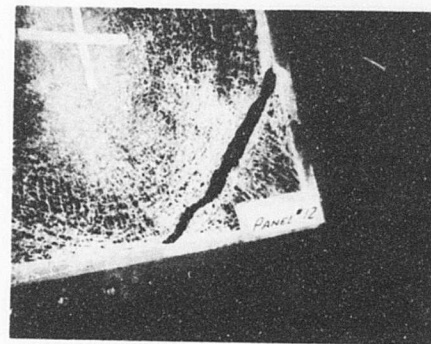
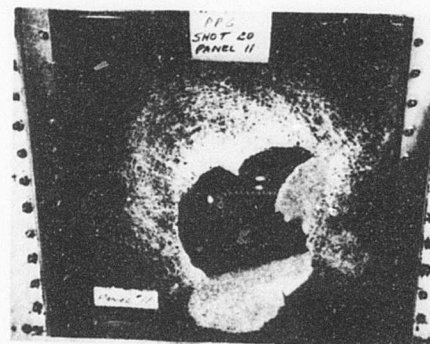
Panel No. 12 at 102 MPH

Panel No. 11 With Flexible Aluminum Extension Ring at 100 MPH

A second test at 100 mph of panel No. 11 attached to an aluminum extension ring demonstrated no advantage. In fact, the results were inferior, since

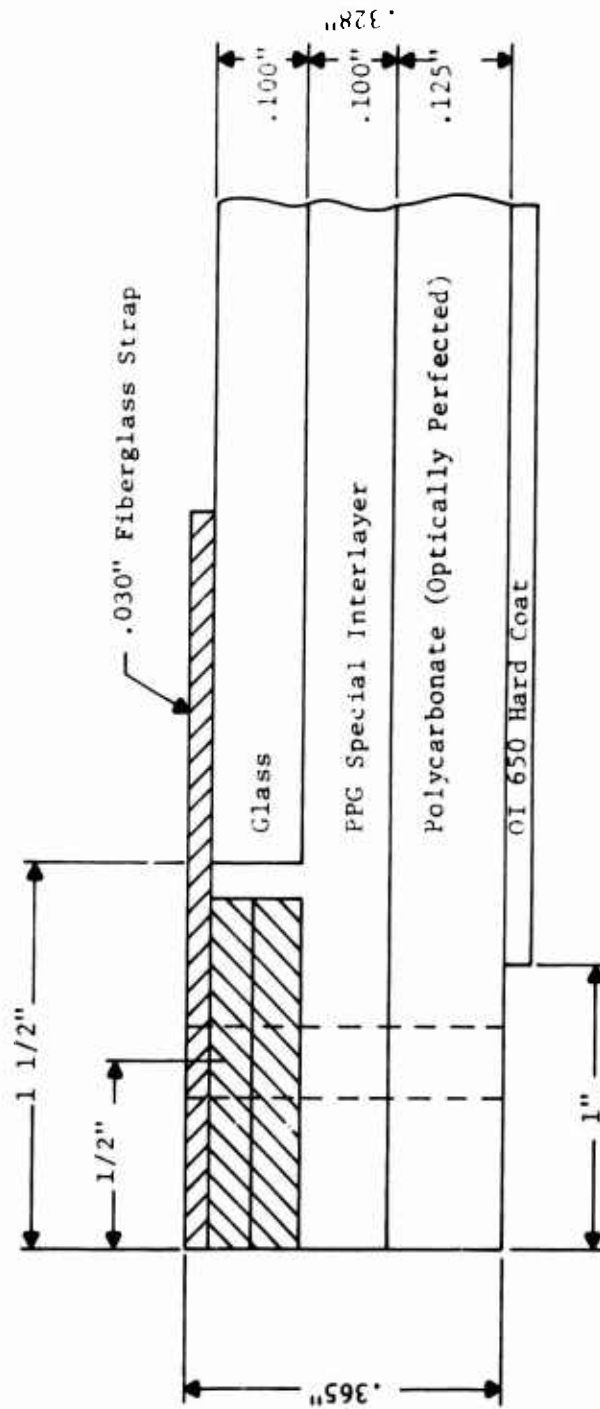
Figure 36. Design IV: Unbalanced Glass-Polycarbonate Composite
 .10-In. Glass - .10-In. Special Interlayer - .125-In.
 Polycarbonate.

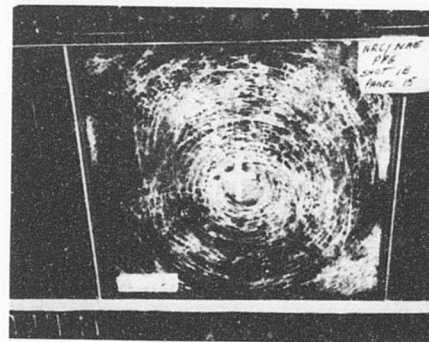
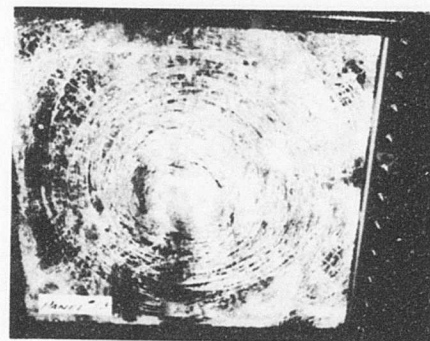
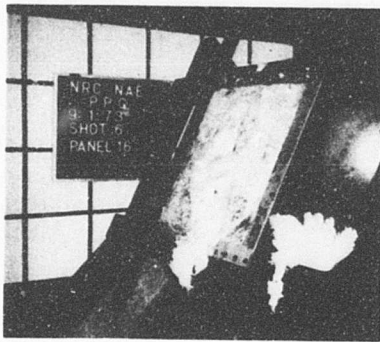
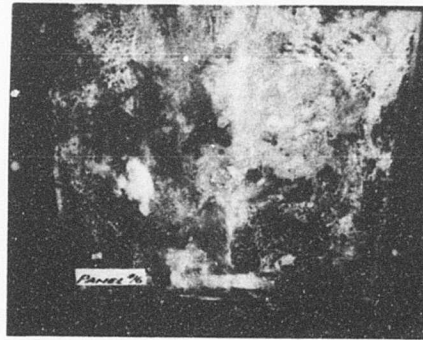
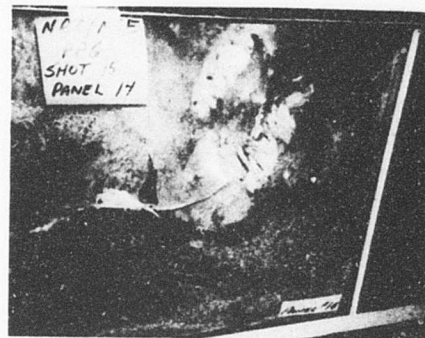
Panel No. 15 at 104 MPH

Panel No. 13 at 147 MPH

Figure 37. Results of 4-Pound Bird Impact Tests of .10-In. Glass - .10-In. Special Interlayer - .125-In. Polycarbonate With Hard Coating.

Panel No. 16 at 201 MPH

Panel No. 14 at 250 MPH

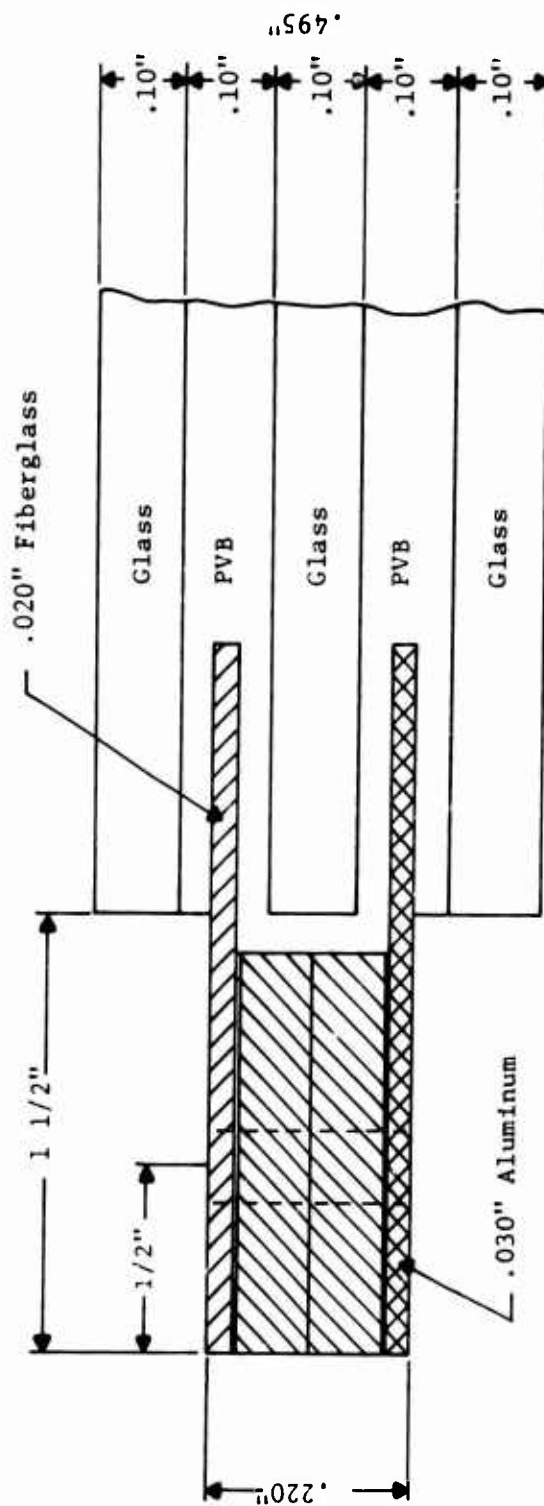
Figure 38. Design V: Three-Ply Glass Laminate
.10-In. Glass - .10-In. PVB - .10-In.
Glass - .10-In. PVB - .10-In. Glass.

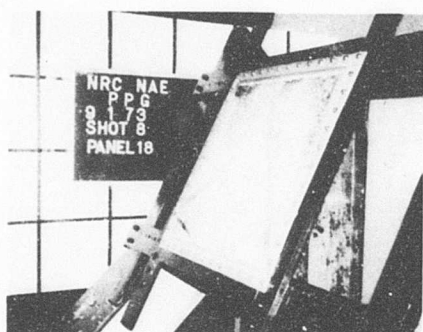
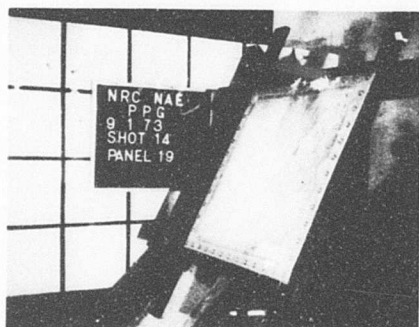
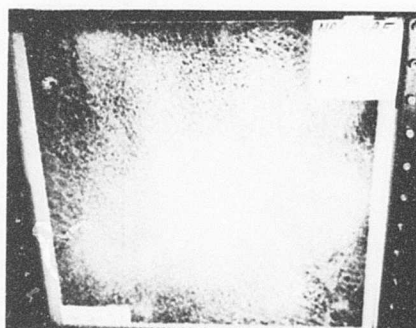
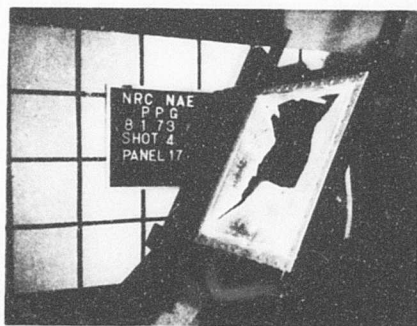
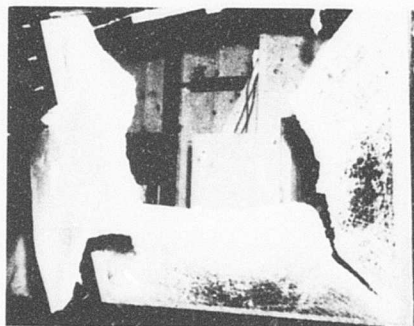
Panel No. 18 at 102 MPH

Panel No. 19 at 126 MPH

Panel No. 17 at 151 MPH

Figure 39. Results of 4-Pound Bird Impact
Tests of .10-In. Glass - .10-In. PVB -
.10-In. Glass - .10-In. PVB - .10-In.
Glass Assembly.

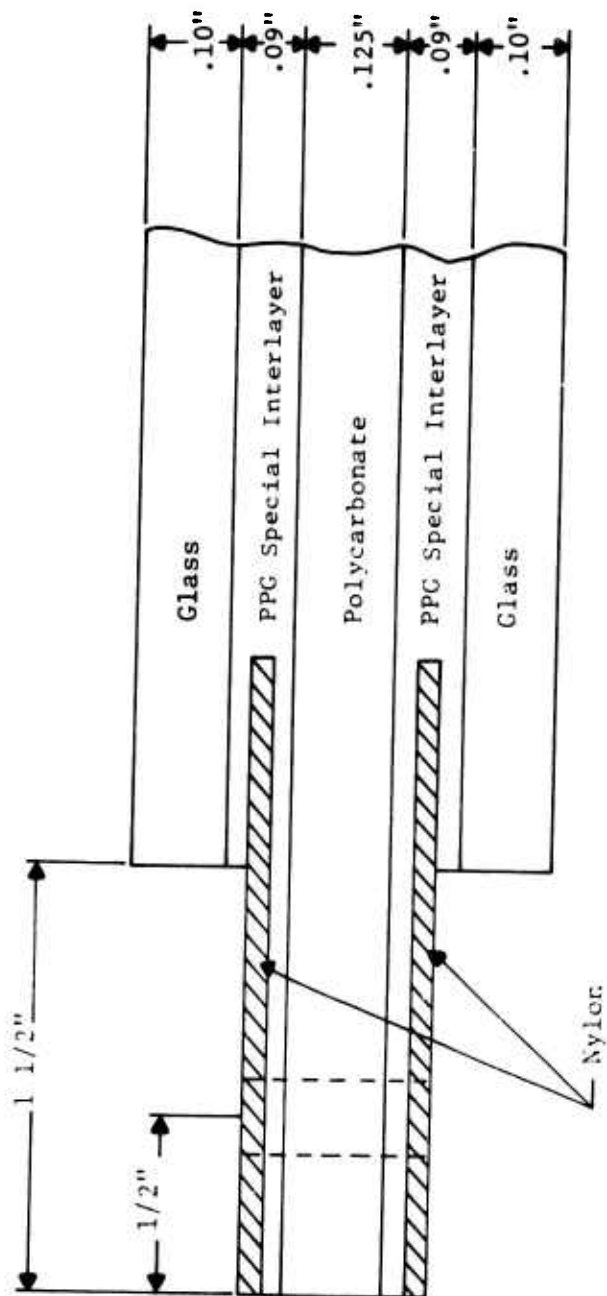
Figure 40. Design VI: Balanced Glass-Polycarbonate Composite
 .10-In. Glass - .09-In. Special Interlayer - .125-In.
 Polycarbonate - .09-In. Special Interlayer - .10-In.
 Glass.

Results of 4-lb bird impacts of balanced glass-polycarbonate design per Figure 40 are shown on Figure 41. This design included 1/8-in. polycarbonate as-received buried between a special interlayer proprietary to PPG Industries. As shown by Figure 41, this balanced design, which could be considered as an additional glass ply attached to design IV, sustained

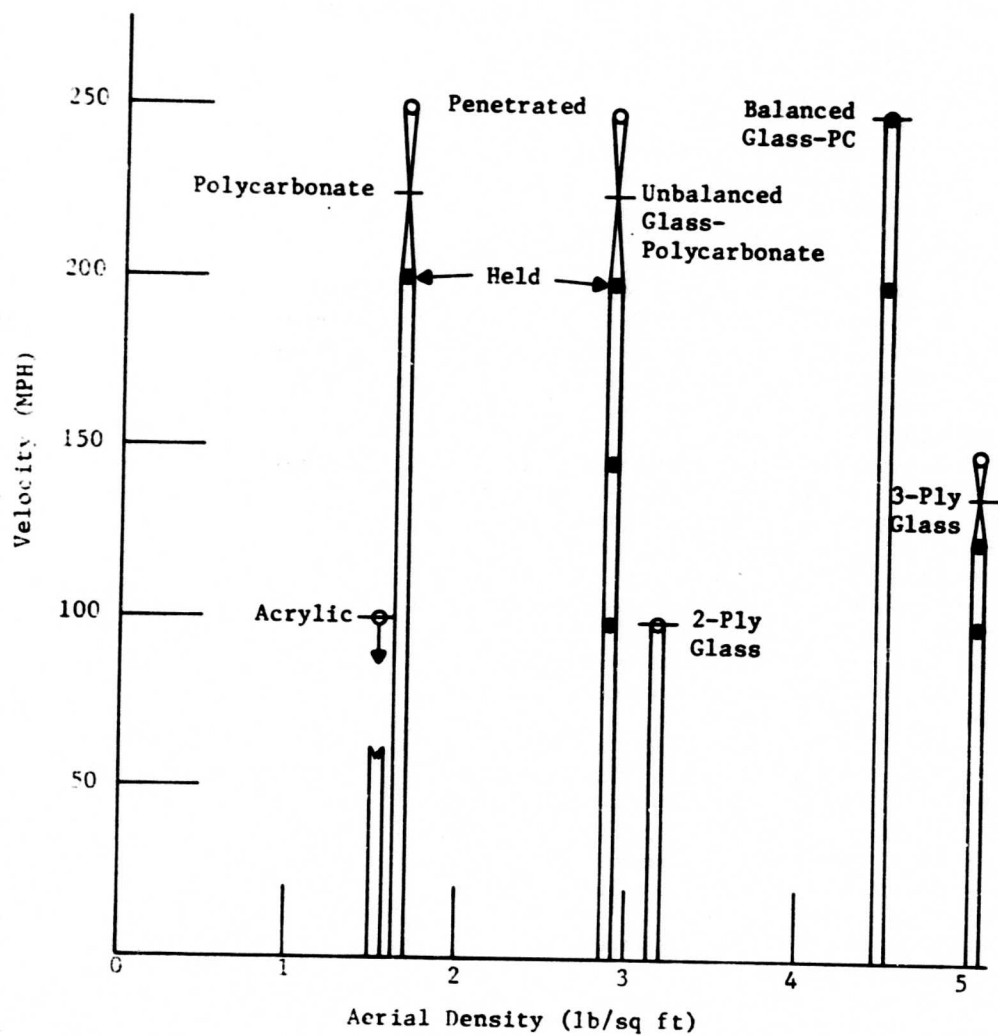
Figure 42. Penetration Limits for Transparent Enclosures Subjected to 4-Pound Bird Impacts at 65° Installation, 70°F.
